AIA Document G704™ - 2000**Certificate of Substantial Completion****PROJECT:**

(Name and address)
Oak Creek Village Apartments
2324 Wilson Street
Austin, Texas 78704

CONTRACT FOR: General Construction
CONTRACT DATE: May 21st, 2014

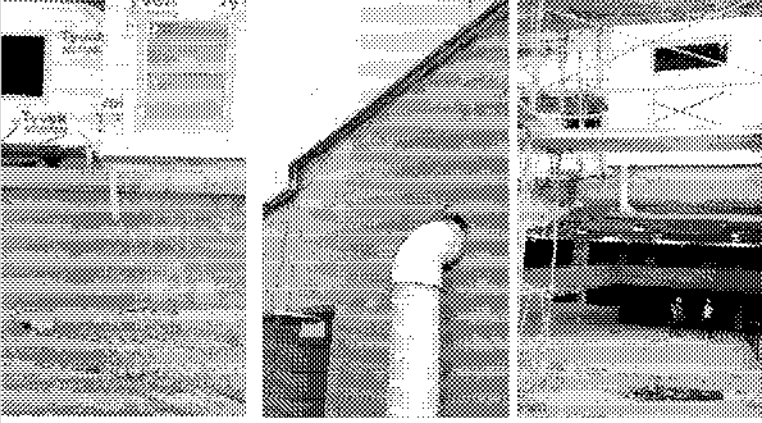
Garage Perimeter	01	<p>Roof drainage from downspouts enters the garage via PVC piping penetrations through garage wall at numerous locations along the west & north walls. BCS recommends that all of these be converted to sheet metal to match the downspouts above, so that no PVC is visible from the exterior.</p>

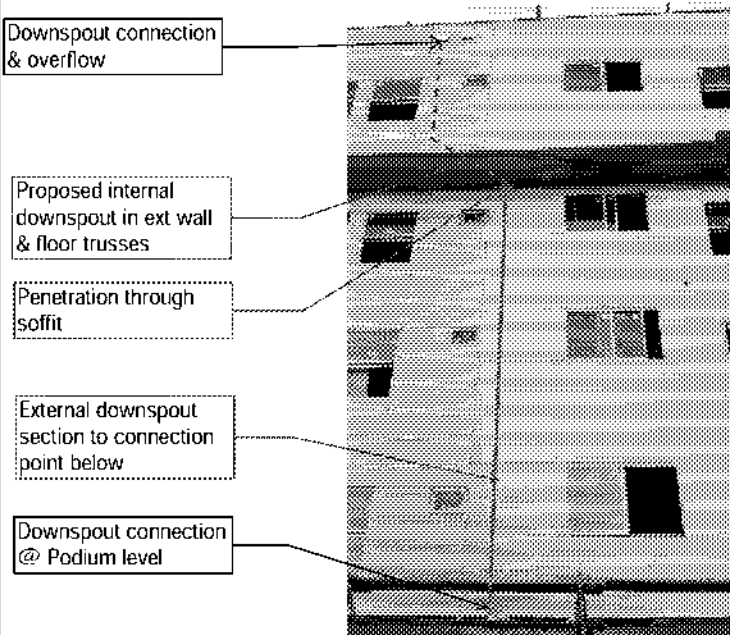
BCS to review with owner & issue direction.
Building A, West	02	<p>Building A has a top-floor cantilever at the NW corner. Two downspouts need to be routed down to penetrations in the podium deck below. BCS recommends that the downspout to run internally through the wall for the top floor only, and then punch through the soffit to run externally for the remainder of the run.</p>

BCS to review with owner & issue direction.

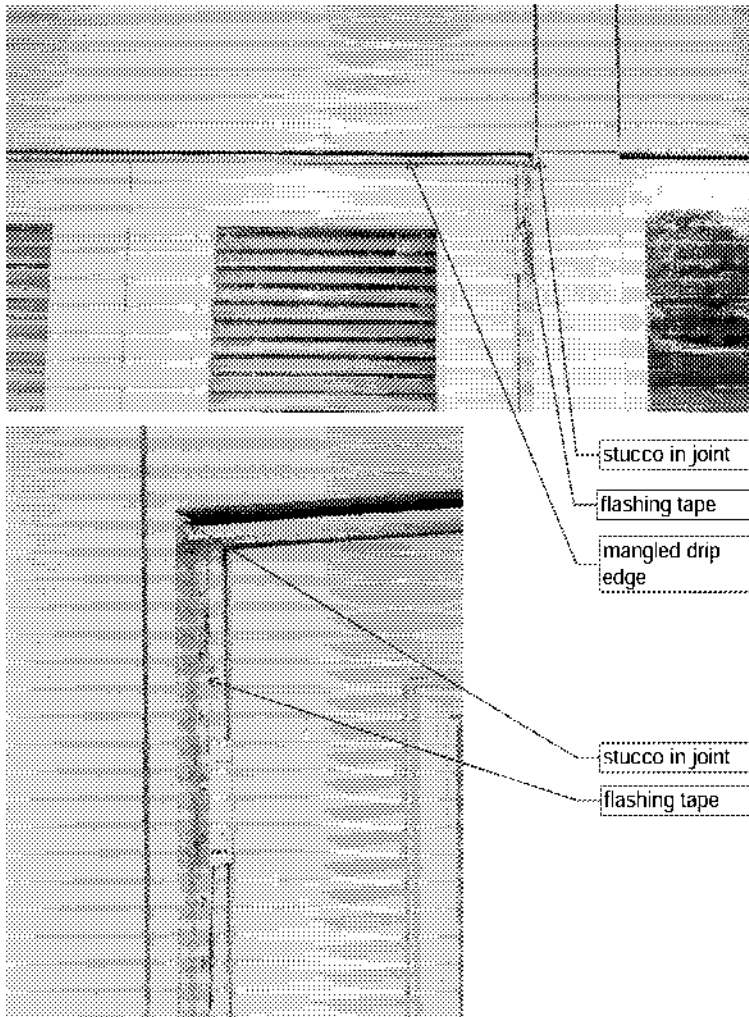
Typical exterior door issues, observed at most locations:

- Sheet metal flashing damaged & installed out of level
- Flashing tape visible
- Stucco & debris wedged in gap above head flashing
- Inconsistent reveal joint size between stucco bead & head flashing strip

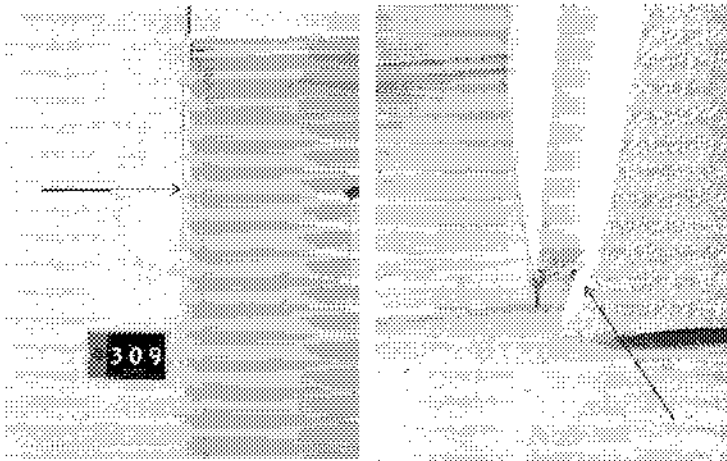
Location	Unit	Observation	Photo
Level 3 Breezeways Buildings B and D	08	Stucco trim conditions at many unit entry door frames are bent, cracked, and dirty. All locations to be straightened, patched, and cleaned as necessary.

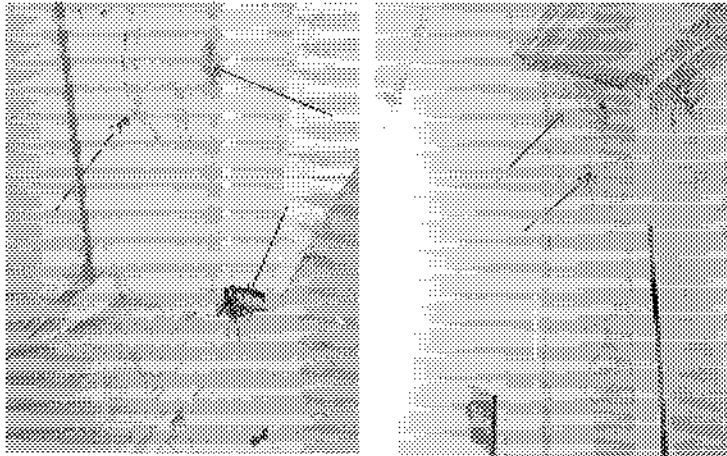
Level 3 Breezeways Buildings B and D	09	Exposed fasteners, stained surfaces, and gaps around entry door frames in many locations. Patch and clean.

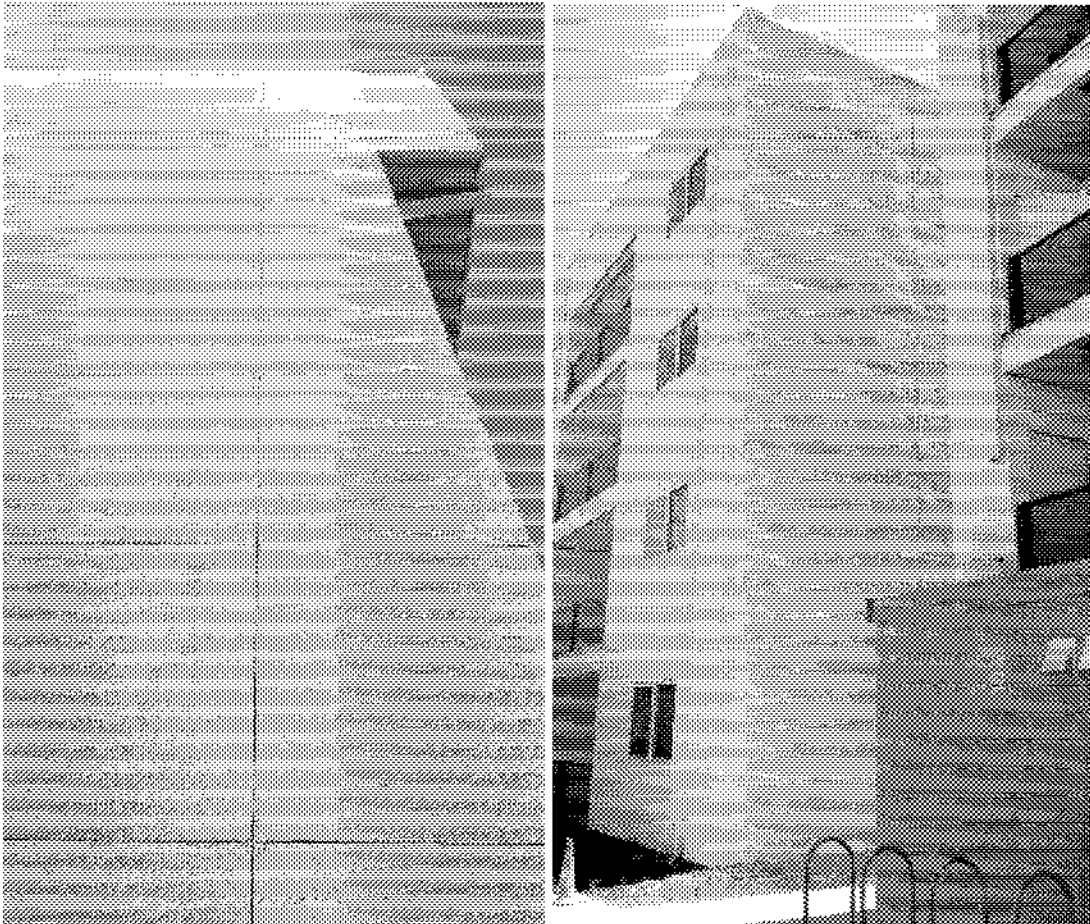
Building 1 West exterior	#7	BCS reviewed downspouts along the west side of Building 1 with Weis. at this point in time, only 2 are installed. BCS to provide guidance for routing of all locations, including connection details at garage wall.	
General Exterior, stucco	#8	Stucco texture is wavy and inconsistent in many locations, below the quality standard established by the mock-up. Many locations appear to be scarred or damaged.

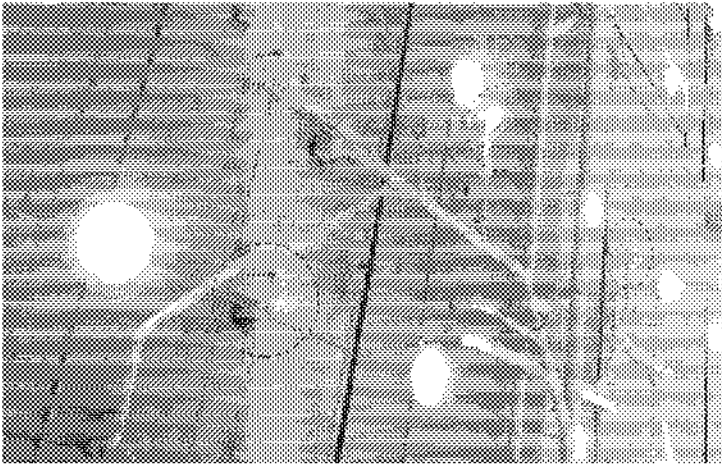
Building C, North end	#4	There is a large gap (12" wide, approx) between podium edge & catwalk, a location that is accessible to tenants. Recommend placing a temporary barricade over this opening, until the concrete topping is poured & the gap is reduced to a code-compliant size (4" sphere).

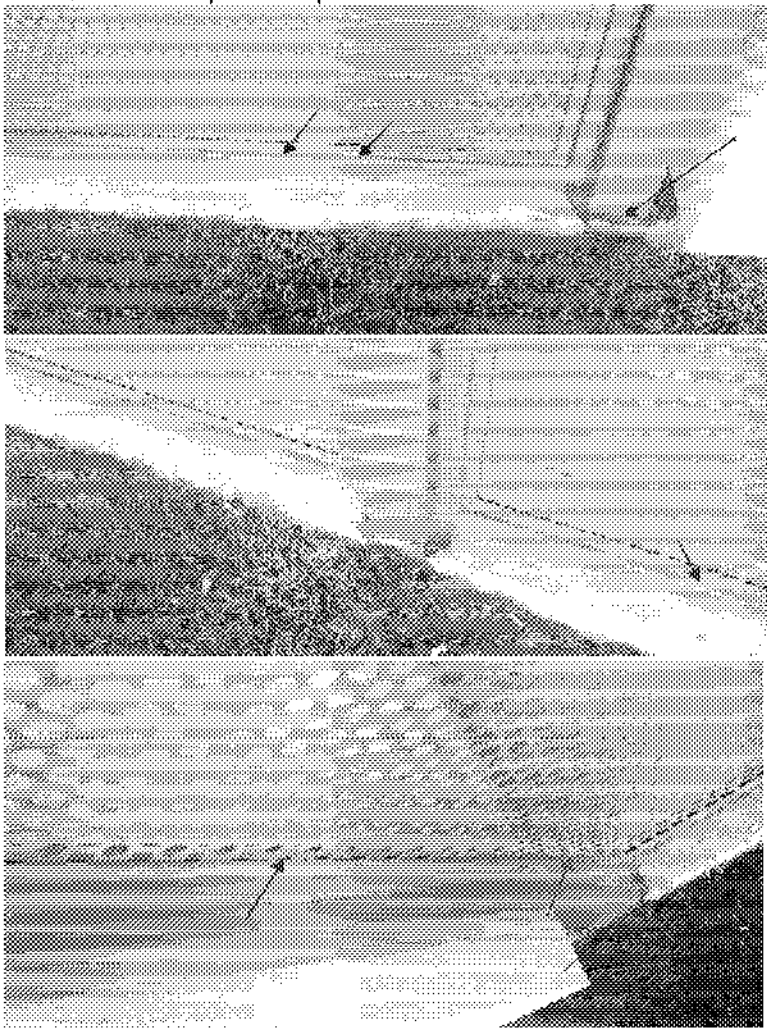
Location	Item	Observation	Photo
Balcony Railings	#12	Balcony rail painting is incomplete at some ground floor post-bases. Also, some rust is visible around perforated panel edges, suggesting either that paint is failing, or more likely that unpainted metal is exposed to weather behind/inside of the perforated panel frame

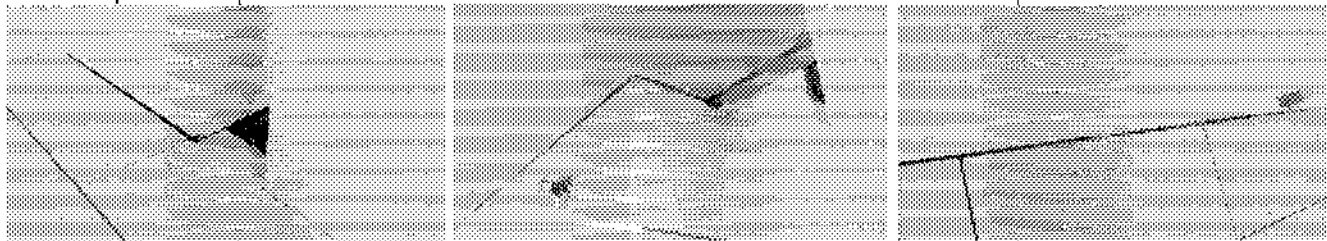
Level 3 Corridors	#5	OSB form boards from topping slab install have been left in place, and are disintegrating. Pavers should directly abut topping slab ramps, with 1/4" max gap. BCS would accept cedar or redwood joint strip as an alternative, but the OSB must be completely removed.

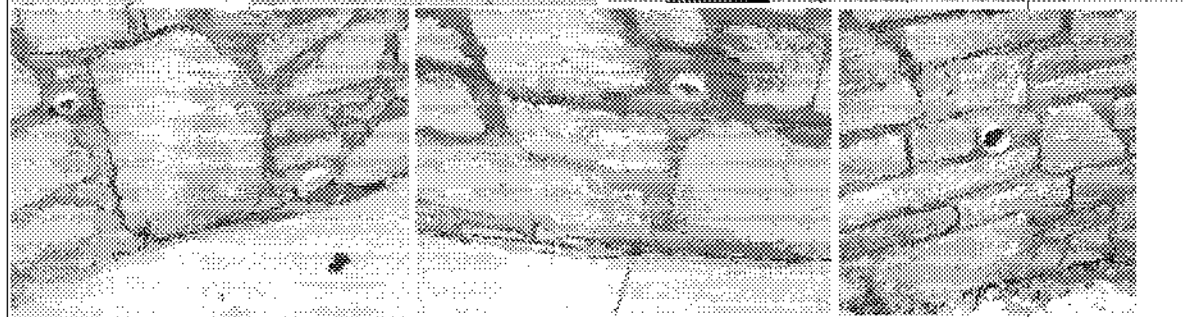
Gravel Beds & Corridors	#3	Podium-level gravel beds & corridors are littered with a fair amount of debris from construction. Recommend complete removal & cleaning prior to tenant occupancy, to establish a clean first impression and good precedent.

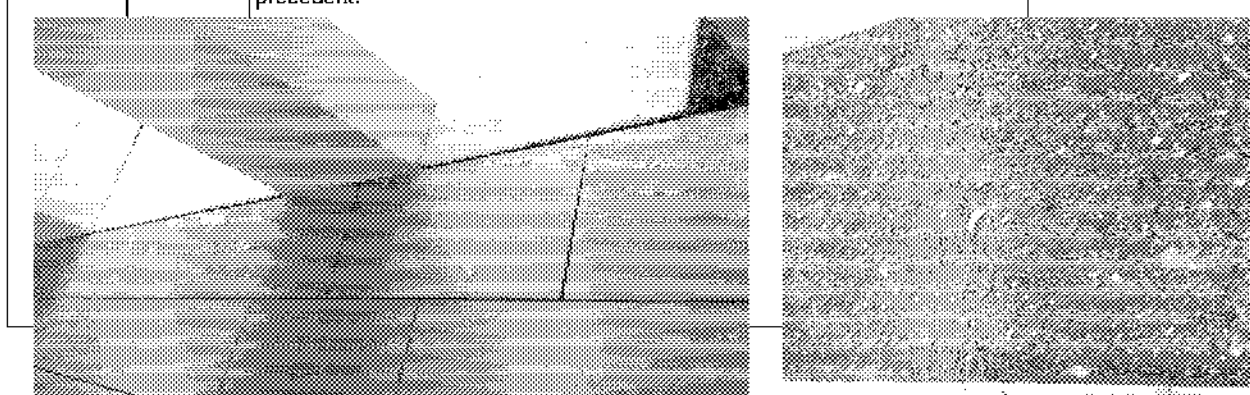
Ramp Transitions	#4	<p>Old OSB forms have been removed from ramp transitions to pavers. The resulting 5/8" to 7/8" gap will need to be filled in flush with a durable, traffic-rated material (redwood, cedar, concrete) to provide a TAS-compliant route.</p>

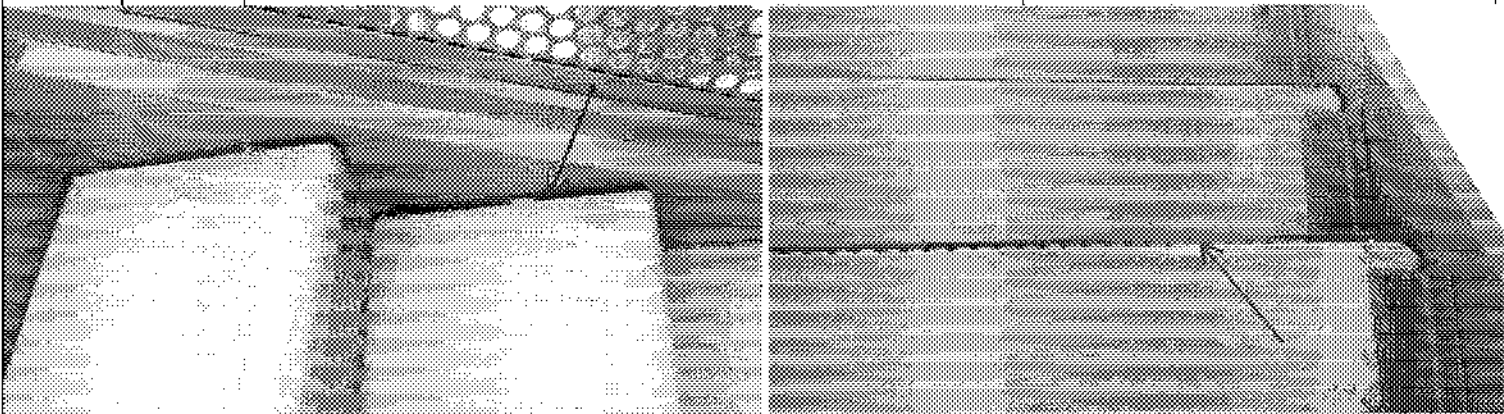
Wall-mount t path lights	#7	<p>Along top floor walkways, several of the low-level path lights have the covers removed / knocked-off. One of the displaced covers didn't have it's set-screw tightened, causing it to fall off easily. Check that these are adjusted for tight fit.</p>

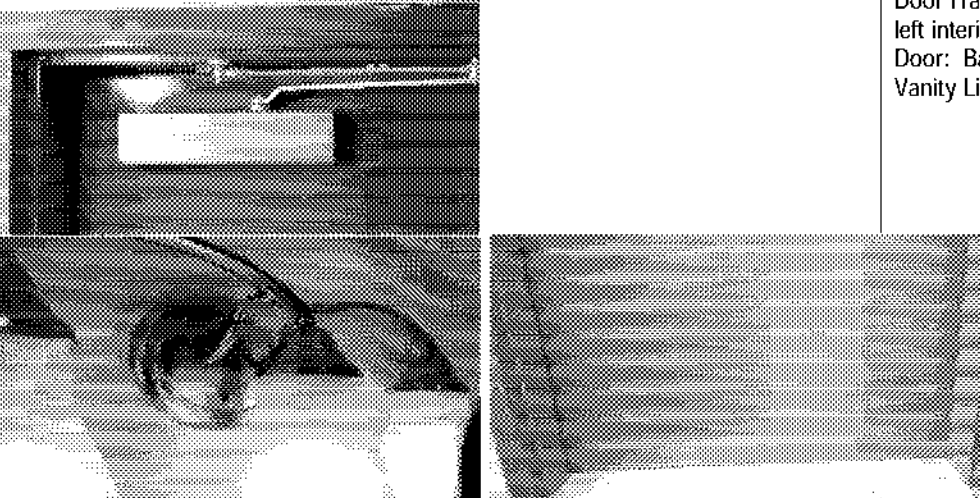
Door Frame: remove dripping paint @ top left interior corner, remove caulk. Door: Bad texture @ bottom 1/3 - repaint Vanity Light: clean base
Women's RR, Bldg 4, Lvl 2

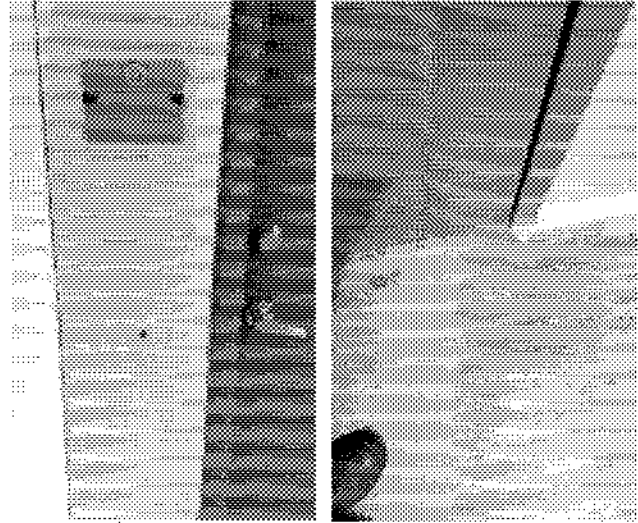
Business Center

<p>Exterior Sign damaged. Repair stucco hole below sign. Perimeter of interior floor appears to have paint overspray in some spots - remove.</p>

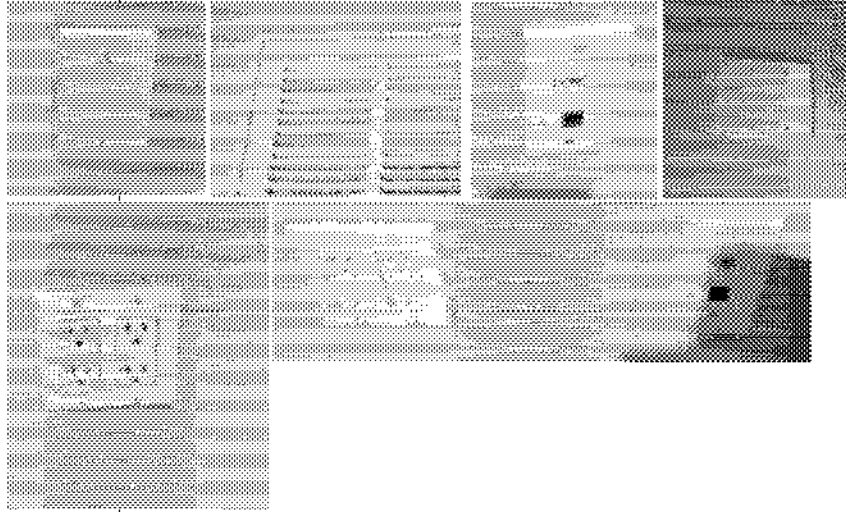
<p>Wall plates: most are painted to the wall. Telecom/Data plates were removed after painting and have cracked painted edges. Remove paint from plates, repair damaged areas.</p>

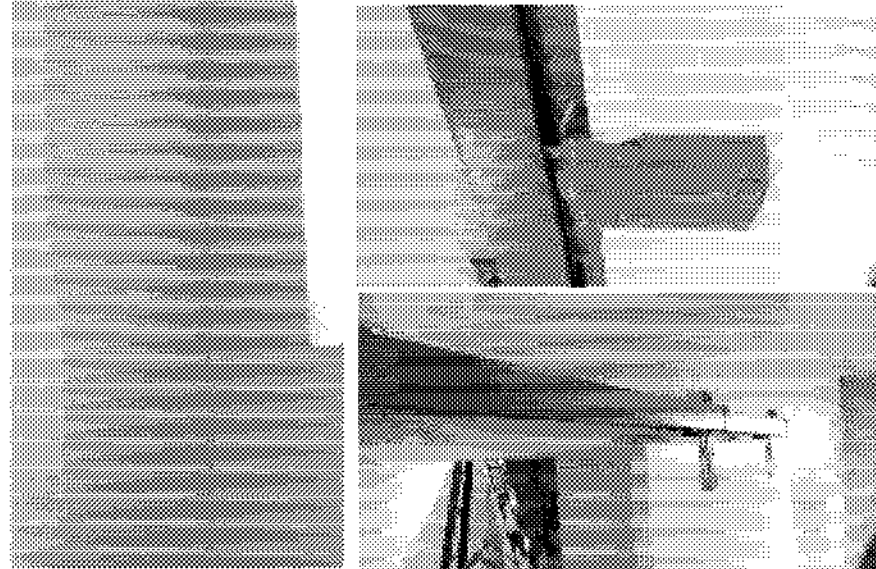
<p>Paint: NE corner near windows needs paint touch up. Door track has inconsistent sheen and needs touch up</p>

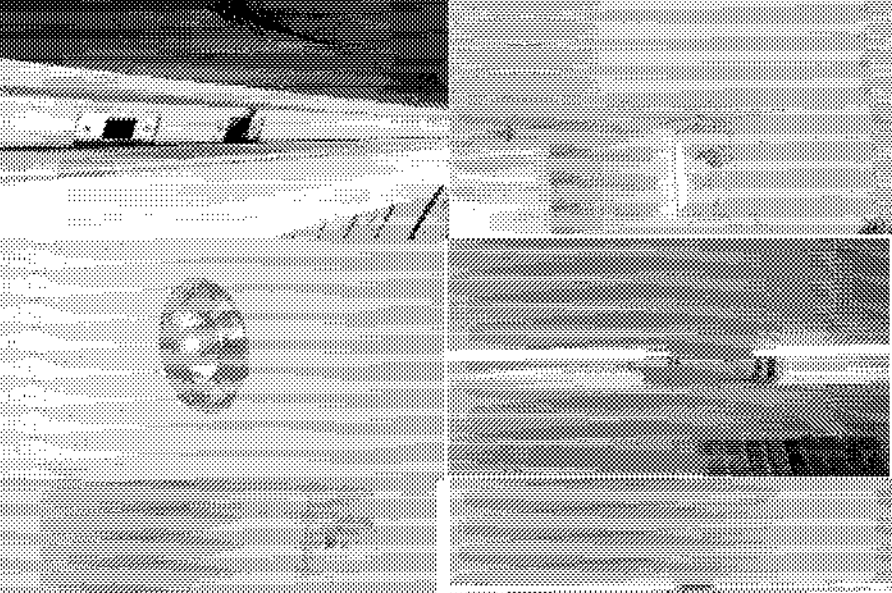
Missing strike plate. Deadbolt strike inset too deep - set flush with frame. Clean floor drain cover to like new condition or replace. Hole in wall above tile (possibly due to data work). Clean light trim & lens. Install grab bars & provide proof of blocking. Remove paint from door hardware. Chip off excess mortar from top edge of wall tile.

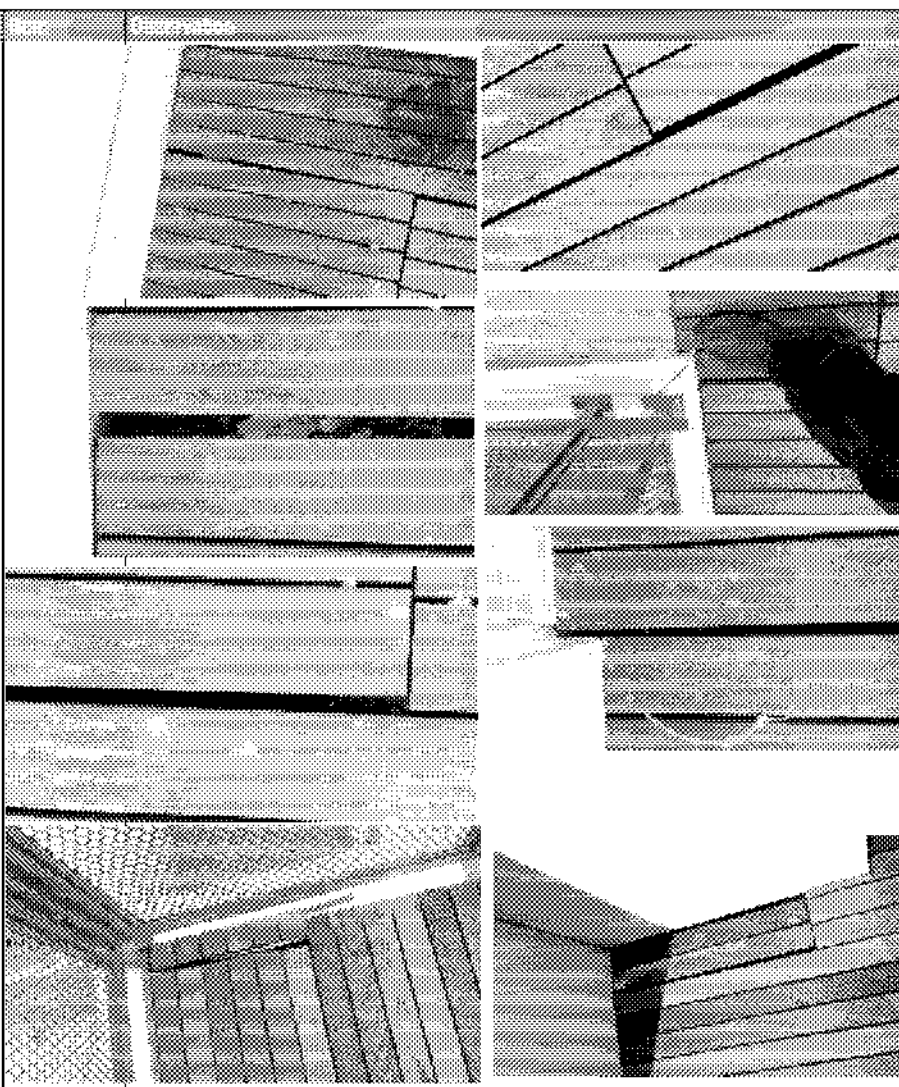
<p>Wood tile installation is generally very poor quality and poses hazards to users. Recommend closing this area off until defective conditions are remedied. Edge tiles are loose and will slide out horizontally in multiple locations. Edge tiles are not well supported in many locations. Center tiles creak and 'give' under foot. Tiles are stained, coated in adhesive residue, and damaged. Construction debris is visible beneath the tiles. Replace all damaged pieces. Fully secure all loose pieces. Stabilize all pieces completely - no creaking or bouncing. Clean to like new condition.</p> <p>Edge conditions at parapets are not installed per detail in PCO-44. These were to be wrapped in ipe material.</p> <p>South closet door is not complete. Weather barrier membrane has been exposed for some time and needs to be trimmed out.</p>
6th Floor Deck

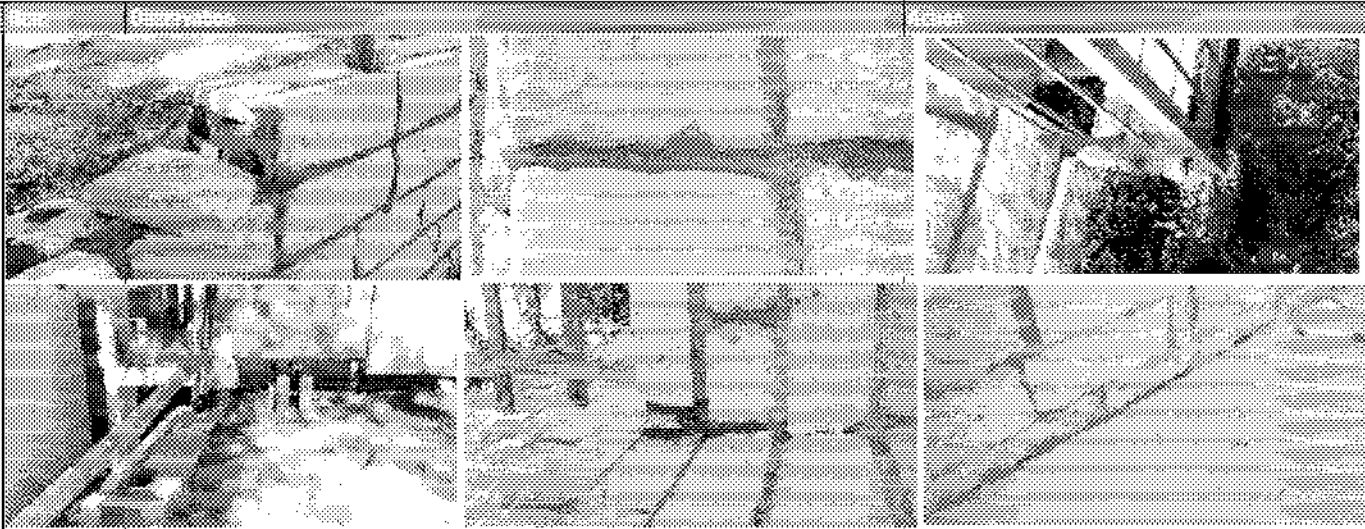
<p>Despite previous repairs, stone retaining walls continue to crumble apart along top edges. Several loose stones observed, and many locations show mortar/stone separation, especially head joints near the top of wall. Holes along tops of walls for future guardrails appear to be a contributing factor, but this issue is more widespread than can be explained by that factor alone. Additionally, workmanship is very poor. Excess mortar was not cleaned from the tall walls facing the building, among other areas. Toothing in repairs are noticeable. Form board for adjacent sidewalks protrudes up above the sidewalk level. Surveyors painted the railing & wall near the SE corner of Building 3.</p>
SE Corner Bldg 3

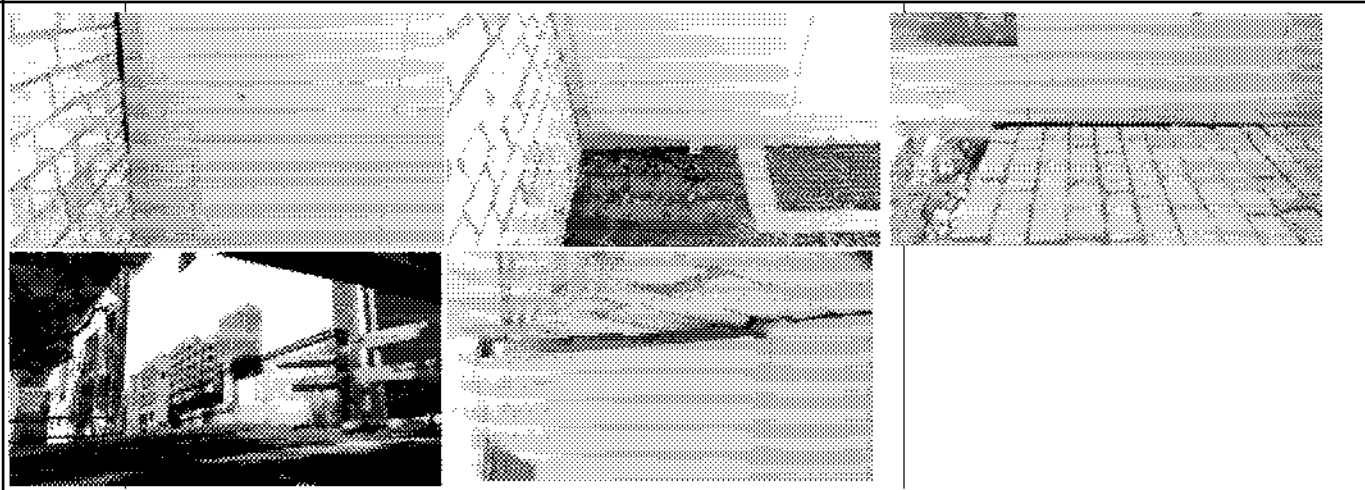
<p>Black waterproofing material is visible @ meeting of retaining wall & building @ east wall, and to a lesser extent the west wall, that is probably not UV-exposure rated. Provide mortar-matched sealant (Aluminum NP-1 or sim.) joint w/ backer rod @ meeting of retaining wall / building on the east-facing wall. Joint should be well sealed at the top, and recessed from stucco face. East wall storm drain does not have a drain assembly - just a cut off plastic pipe flush with grade.</p>

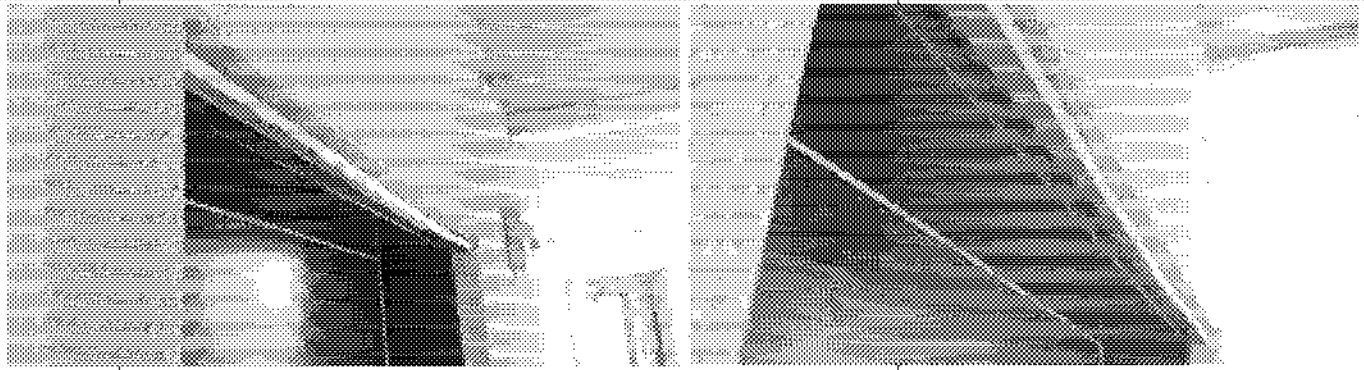
<p>Most door head flashings are still unacceptable. Make repairs discussed previously.</p>
Exterior Wall Base @ podium level

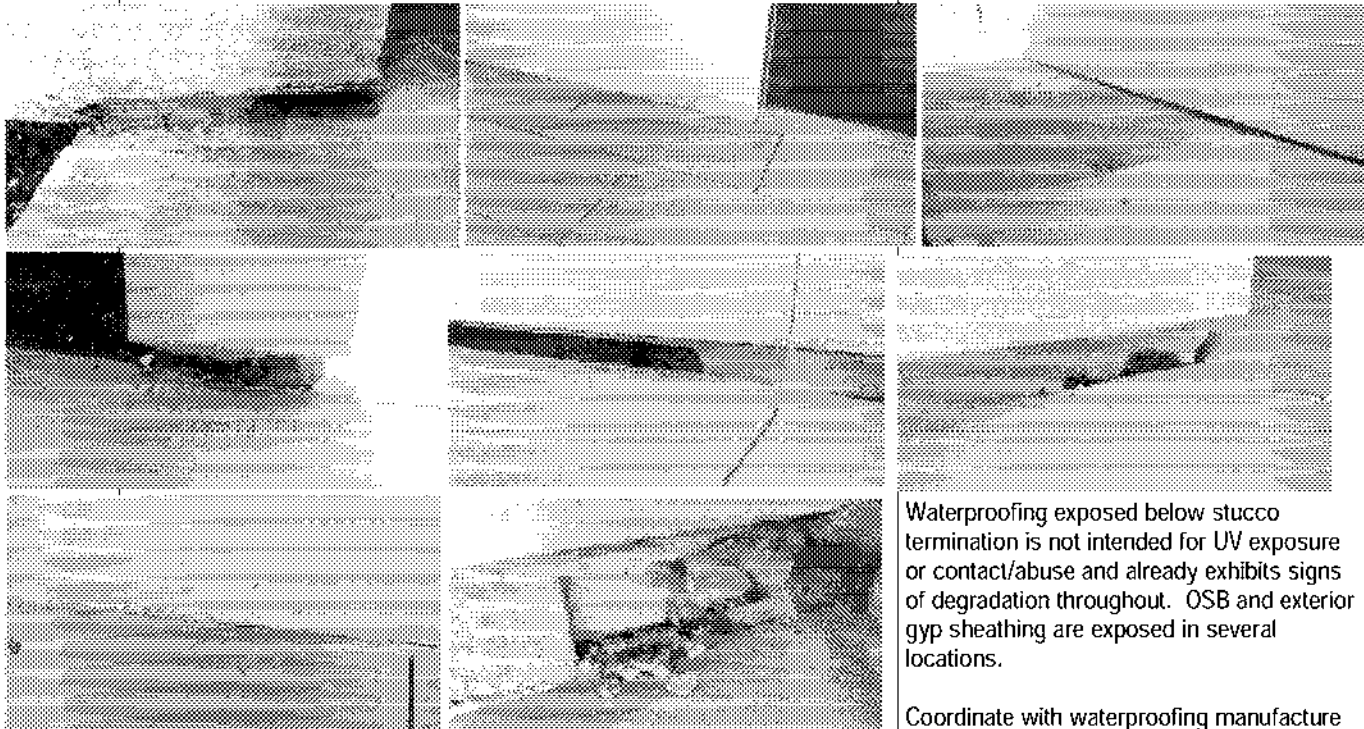
<p>Waterproofing exposed below stucco termination is not intended for UV exposure or contact/abuse and already exhibits signs of degradation throughout. OSB and exterior gyp sheathing are exposed in several locations.</p> <p>Coordinate with waterproofing manufacture for repair options that will maintain warranty and improve appearance.</p>
Exterior steel

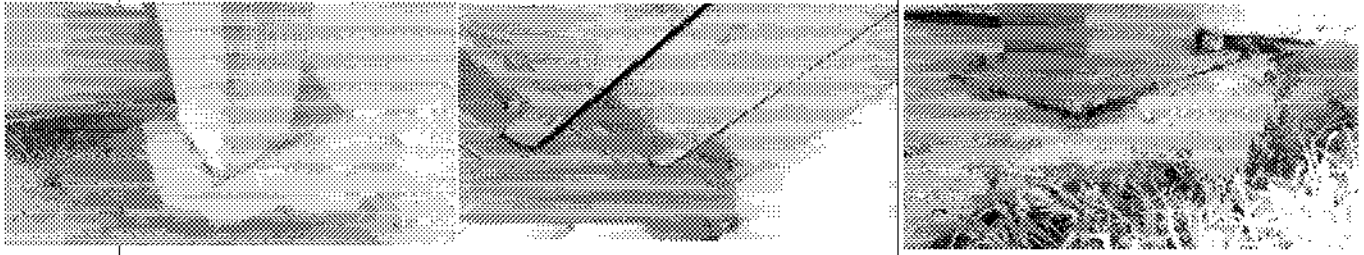
<p>As noted previously, exterior steel is not completely painted in many locations, and is already generating rust staining. Remove rust and fully paint exterior steel per construction documents.</p>

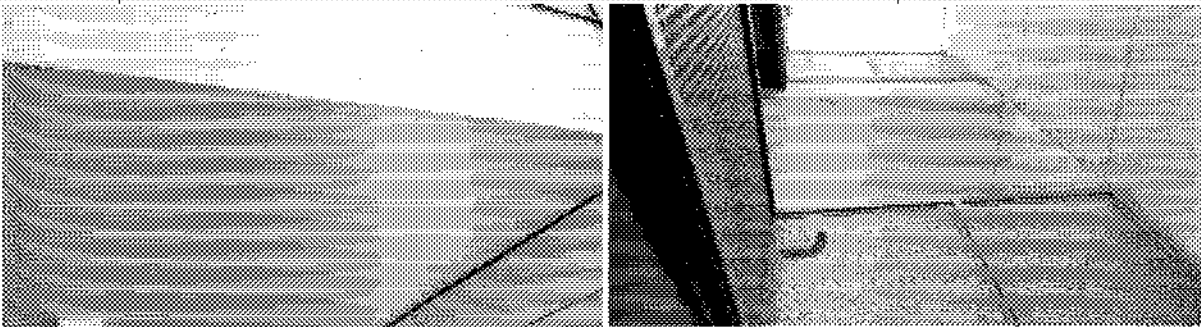
<p>Remove water damaged soffit material, and any other material affected. Remove unpainted hardie fascia pieces. Install drip edge flashing behind hardie fascia as previously discussed. Pre-paint new hardie fascia before installation. Align exposed fastener heads</p>
Light Shields, North end

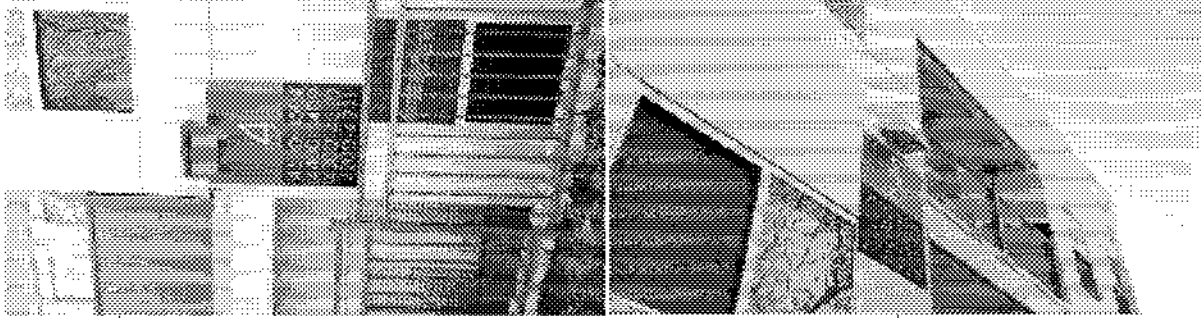
<p>Remove temporary cardboard/tape from Building 4 lights. Building 2 light shield extensions look terrible and are not accepted. Fabricate 2 new shields based on PCO 64 dimensions. Do not remove existing shields until replacements are ready.</p>
Garage, North
